Inspection Report

Property Address:
123 Sample Street
Sample MI 49999

Firm Foundation Home Inspection, LLC

Date: 9/9/2015	Time:	Report ID:
Property: 123 Sample Street Sample MI 49999	Customer: Home Buyer	Real Estate Professional: Buyer's Agent

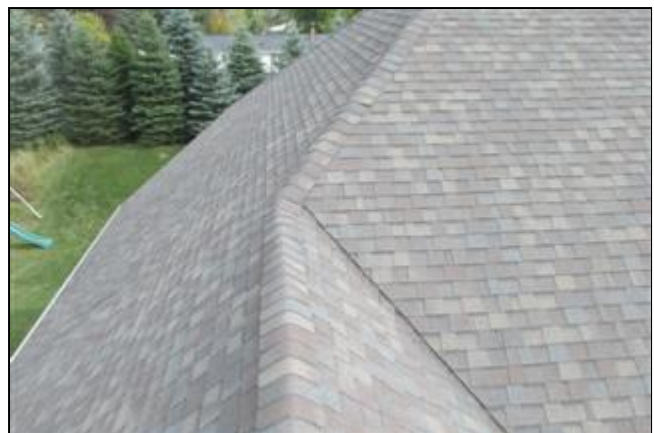
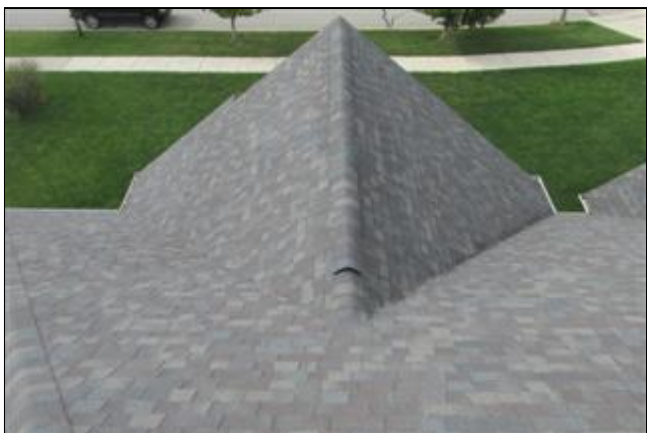
Comments: Inspected
View of roof (Pictures 1 & 2).

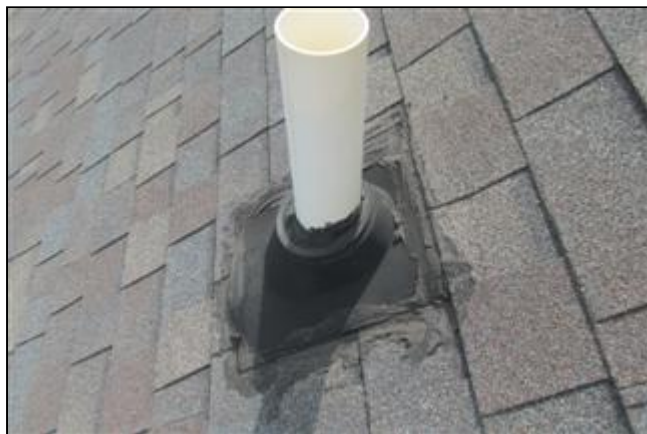
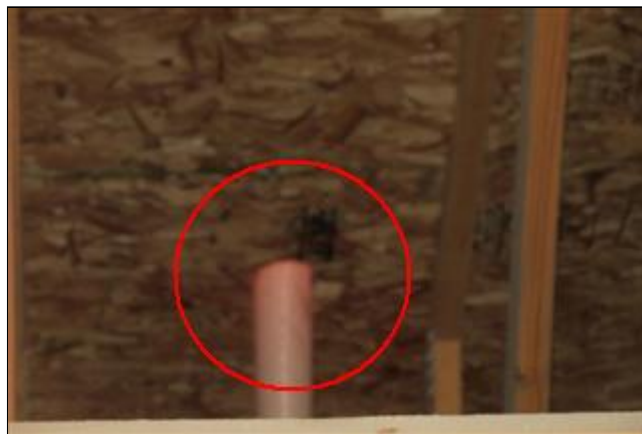
The plumbing vent is not properly installed on the roof--most of the weather flange is secured down on top of the shingles instead of the top half tucked up under the shingles (Picture 1). Someone has tried to compensate by keeping the joint tarred, but I recommend having the weather flange properly installed by a licensed roofer. *Fortunately there is no evidence of moisture penetration as seen from the attic below (Picture 2), but this could change if the caulking fails or is not aggressively maintained.*

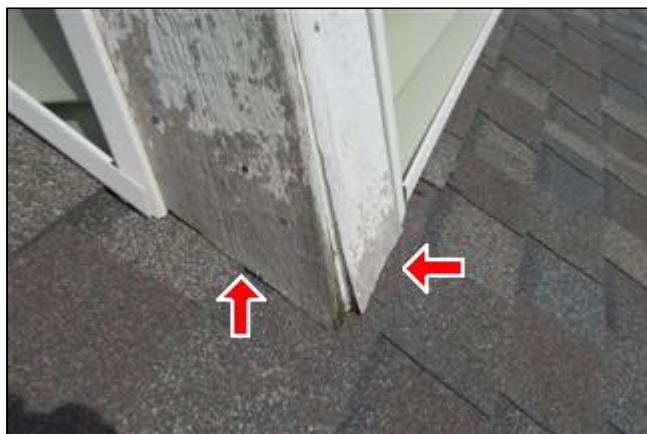
1.3 Picture 1

The composite wood trim on the corners of the chimney extend all the way to the shingles. There should have been a gap between the two materials. Moisture has been wicking up the end grain and has deteriorated the bottoms of these boards (Picture 1). Repair and/or trim replacement is needed.

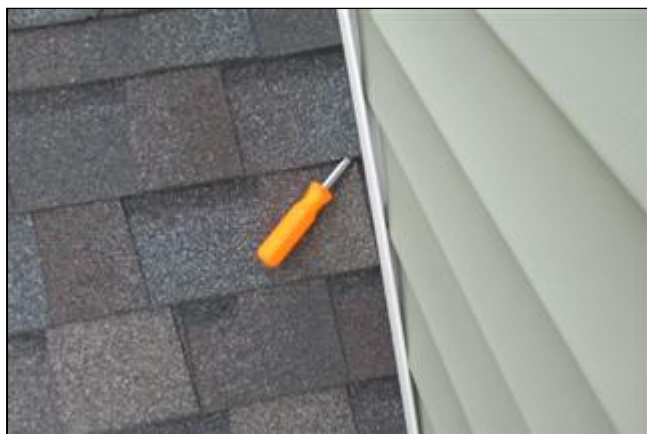
1.4 Picture 1

The house roof has proper step-flashing at the locations where roof lines butt against vertical walls (Picture 1).

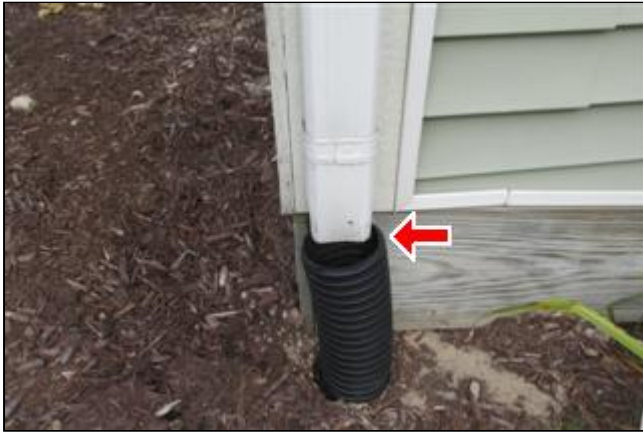
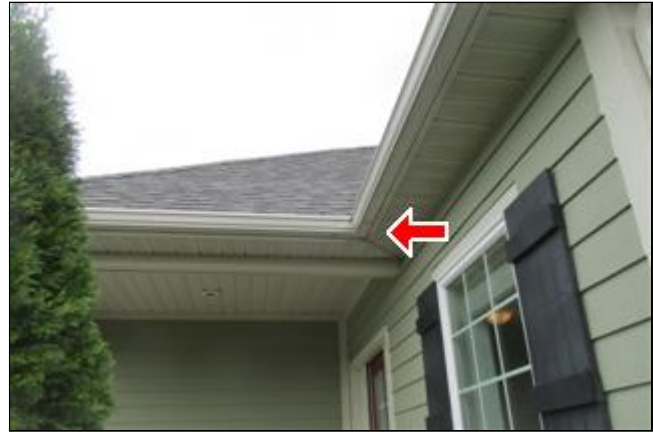
There is separation or gap present between the ground drain-line & the rain gutter at the south side of the house (Picture 1). This needs to be corrected by a qualified individual to properly channel rain water away from the house & surrounding yard/soil grades. Otherwise, erosion or foundation wall moisture penetration issues can arise. Also, the home buyer should observe (during a rain storm) the inside corner of the gutter that is by the front porch (Picture 2). It may be that the large volume of water cascades over the top of the gutter at this location, which may be the cause of the moisture listed at paragraph 5.0. If so, then provision will need to be added to contain all of the roof water shed into the gutters (likely by adding some splash guards).

There is separation or gap present between the ground drain-line & the rain gutter at the south side of the house (Picture 1). This needs to be corrected by a qualified individual to properly channel rain water away from the house & surrounding yard/soil grades. Otherwise, erosion or foundation wall moisture penetration issues can arise. Also, the home buyer should observe (during a rain storm) the inside corner of the gutter that is by the front porch (Picture 2). It may be that the large volume of water cascades over the top of the gutter at this location, which may

be the cause of the moisture listed at paragraph 5.0. If so, then provision will need to be added to contain all of the roof water shed into the gutters (likely by adding some splash guards).

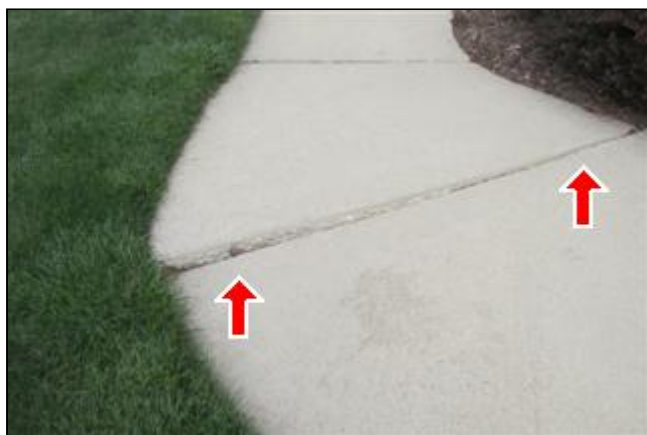
2.2 Picture 1

There are sections of sidewalk that have settled, and trip hazards are present (Picture 1). These areas pose a potential safety hazard that should be repaired/replaced (possibly mud-jacked back to a level position) by a qualified individual.

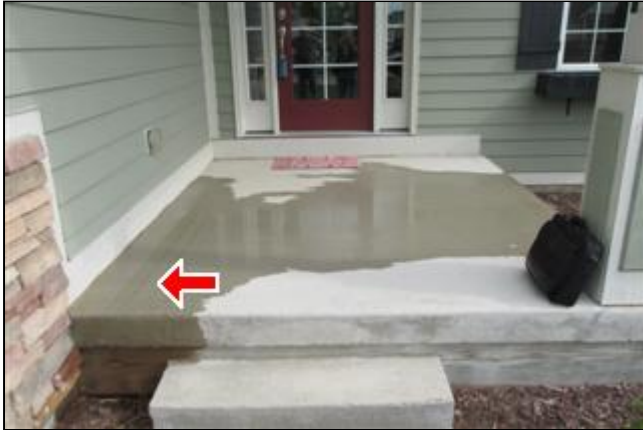
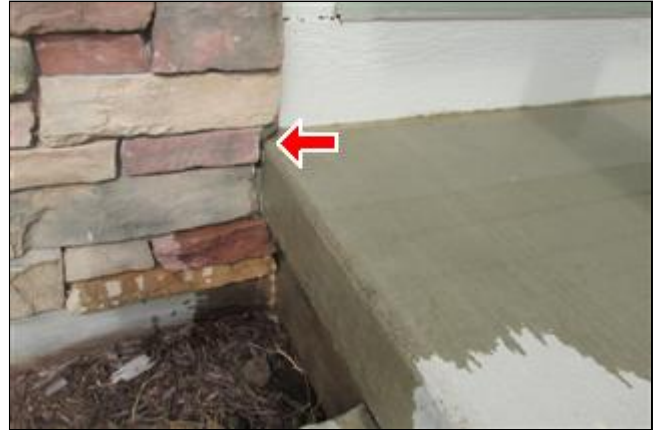
The front porch has settled a little, and it was not poured with slope away from the house. The porch slants toward the house right to the spot where it meets the cultured stone and composite siding material (Pictures 1 & 2). Any time wind accompanies rainy weather, water will land on the porch and run against the siding material. This is a vulnerable point of the structure, as water can easily seep into the wall sheathing behind the siding and cause damage. This water

The front porch has settled a little, and it was not poured with slope away from the house. The porch slants toward the house right to the spot where it meets the cultured stone and composite siding material (Pictures 1 & 2). Any time wind accompanies rainy weather, water will land on the porch and run against the siding material. This is a vulnerable point of the structure, as water can easily seep into the wall sheathing behind the siding and cause damage. This water issue needs to be corrected, at a minimum by pro-actively maintaining a caulk joint between the concrete and siding, but possibly by tearing out the porch and re-pouring it with proper slope.

issue needs to be corrected, at a minimum by pro-actively maintaining a caulk joint between the concrete and siding, but possibly by tearing out the porch and re-pouring it with proper slope.

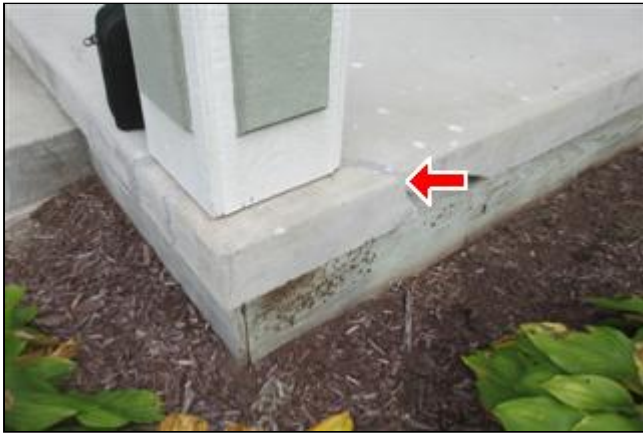
2.3 Picture 3

The cracked corner of the porch is probably not significant (Picture 3), since the post and concrete is resting on the foundation frost wall below.

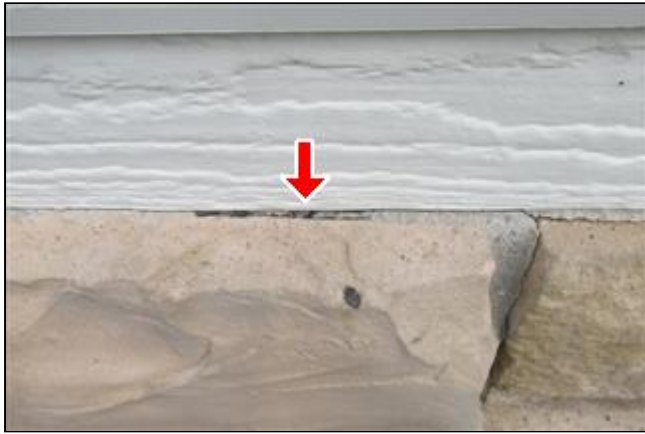
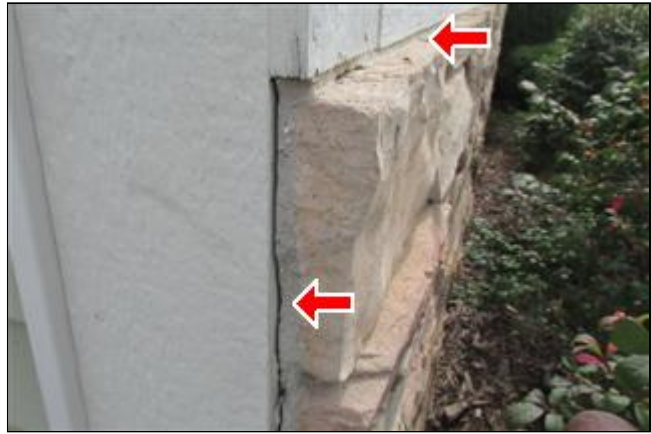
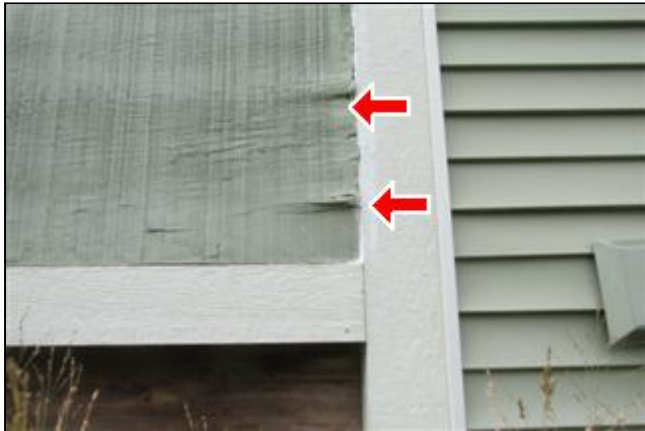
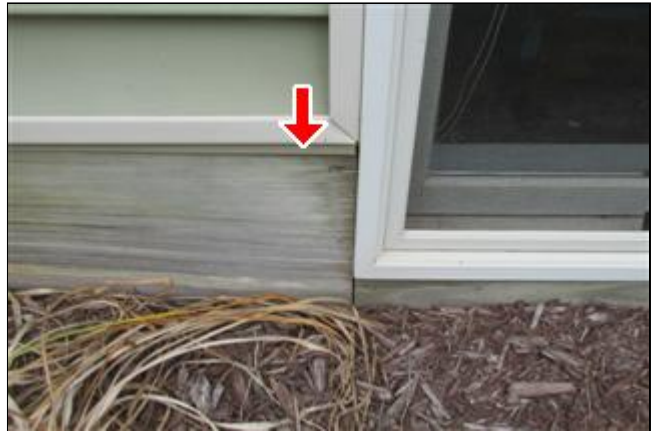
- 🏠 The cultured stone at the front of the house was not installed with proper flashing methods. Some of the stone surfaces slope back toward the house, and there is no metal drip-cap flashing protecting the joint from water being able to penetrate behind the stone (Picture 1). At a minimum this intersection needs a pro-active and regular caulk application (Picture 2), but it really should have the proper drip cap flashing and/or correction of the top stone to slope away from the house. A few other siding issues include needed repair to some damaged plywood at the screened porch (Picture 3) and the need to keep the drip cap flashing lapping over the wood skirting at the rear of the house (Picture 4).

The cultured stone at the front of the house was not installed with proper flashing methods. Some of the stone surfaces slope back toward the house, and there is no metal drip-cap flashing protecting the joint from water being able to penetrate behind the stone (Picture 1). At a minimum this intersection needs a pro-active and regular caulk application (Picture 2), but it really should have the proper drip cap flashing and/or correction of the top stone to slope away from the house. A few other siding issues include needed repair to some damaged plywood at the screened porch (Picture 3) and the need to keep the drip cap flashing lapping over the wood skirting at the rear of the house (Picture 4).

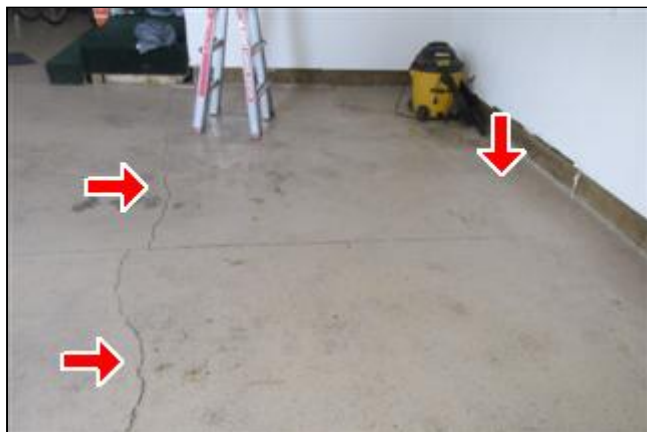
3.2 Picture 1

The back-fill soil at the south end of the garage was not properly compacted during the construction stage of the house, and the floor has cracked and settled (Picture 1). Any water or snow melt in this half of the garage will not run out the garage doors, but will puddle up against the back wall. This can possibly be corrected by a process known as mud-jacking, which typically costs only half the price of concrete replacement.

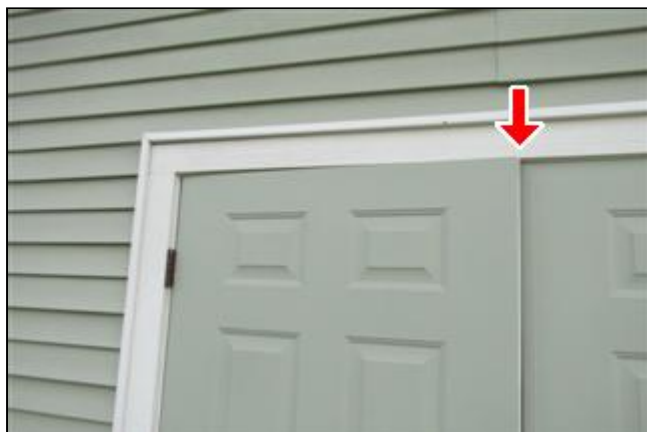
3.3 Picture 1

The garage service doors rub against each other at the top (Picture 1) and an adjustment to the hinges or side jamb is needed to allow for proper operation.

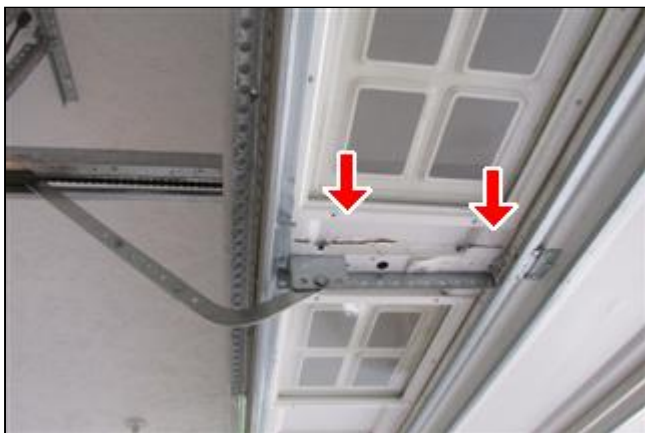
3.5 Picture 1

The top panel of the garage door is damaged where the motor operator arm attaches (Picture 1). This will need repair, possibly with a replacement of the top door panel.

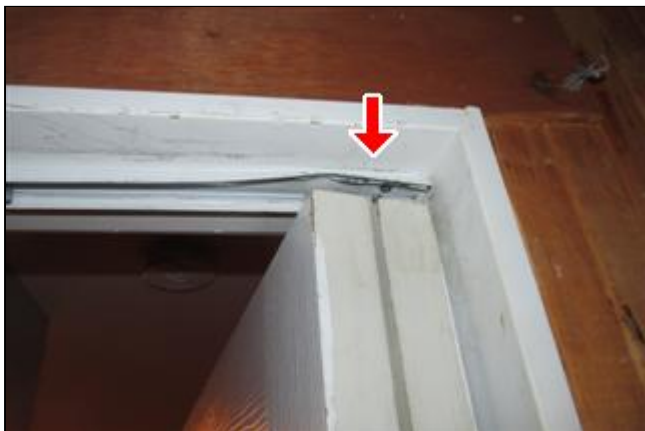
4.5 Picture 1

There is at least one interior door that rubs against the door frame and will not close properly. Cutting, sanding, or other adjustments will be necessary to the door or the door frame to correct this deficiency. Also, the metal track for the bi-fold doors leading to the mechanical room is damaged and will need to be replaced (Picture 1).

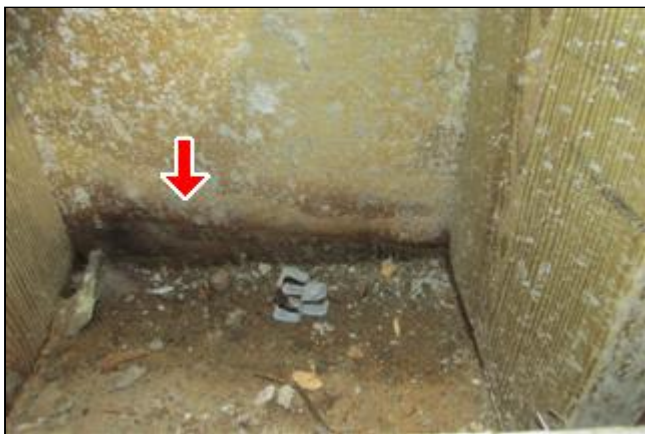
5.0 Picture 1

This house has a wood foundation system. Wood foundations are not typically considered as strong, water-proof, or long-lasting as poured concrete foundations, but they do serve adequately on soil types that are more sandy in nature. Sandy soils retain less moisture and put less pressure on foundation walls, so those types of soil are best suited for wood foundations. Fortunately, it appears this house has sandy or well-drained soils, based on the proximity of some sand/gravel pit activity and the presence of a dry sump pump in the house. There is one spot, however, where moisture penetration is present at the base of the foundation wall, and it coincides with the inside gutter location next to the front porch (see note at paragraph 1.6). I recommend taking steps to eliminate this moisture penetration, either by correcting the soil grade by the front porch and/or correcting the gutter issues.

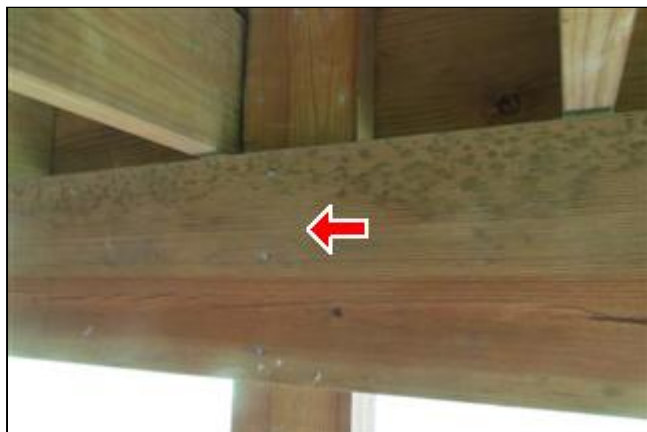
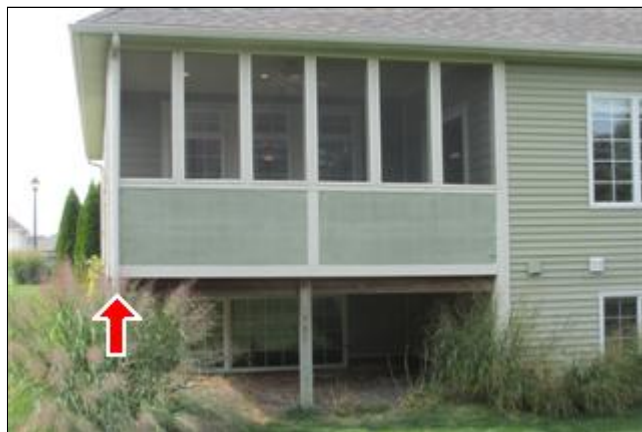
The undergirder for the screened porch room at the southeast side of the house needs proper carriage bolts or lag screws to secure it to the support posts (Picture 1). Nails alone are not sufficient to guarantee the undergirder doesn't sag and fall away from the vertical posts, especially when those nails are pneumatically driven vs hand driven spikes. Also, whoever built the deck portion of this room did not put the undergirder in a level position. The south side of the undergirder is 1 - 2 inches higher than the north end, making the whole room and corresponding roof line non-level (Picture 2). This is not desirable, and not very correctible at this point in time.

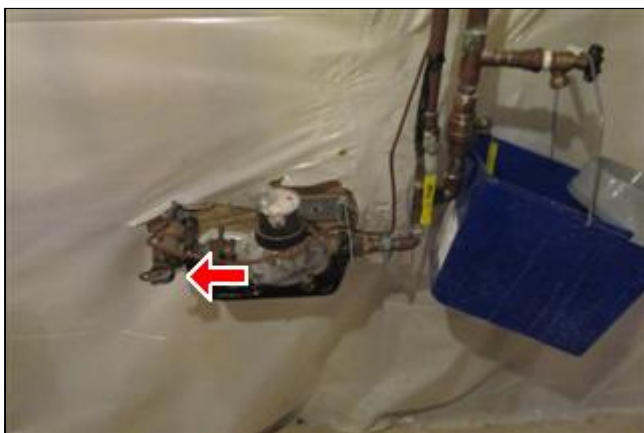
6.5 Picture 1

The main water shut off for this property is the dark colored knob located in the basement (Picture 1) . This is for your information.

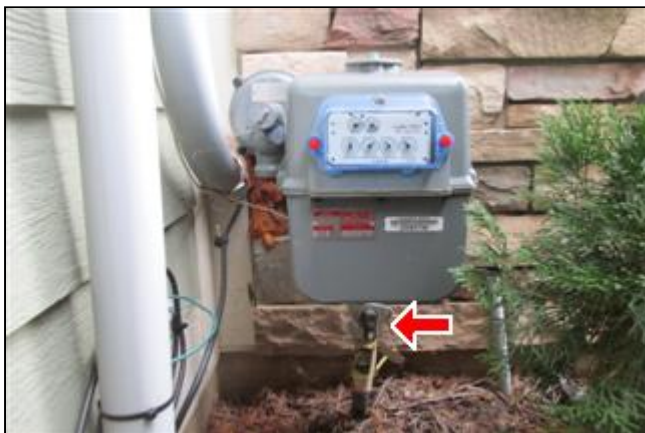
6.7 Picture 1

The main fuel shut off is at the gas meter outside (Picture 1).

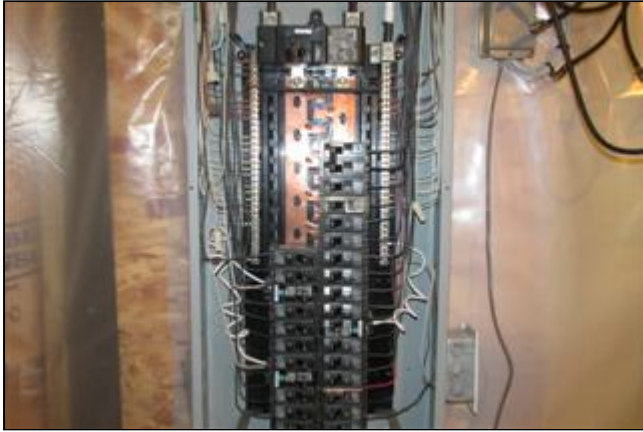
7.6 Picture 1

The main electrical panel box is located in the basement (Picture 1) .

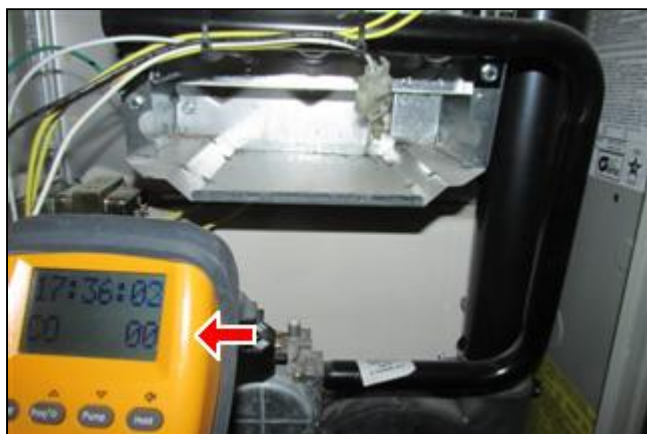
8.1 Picture 1

The furnace passed a carbon monoxide test, conducted with a UEI CO91 tester (Picture 1).

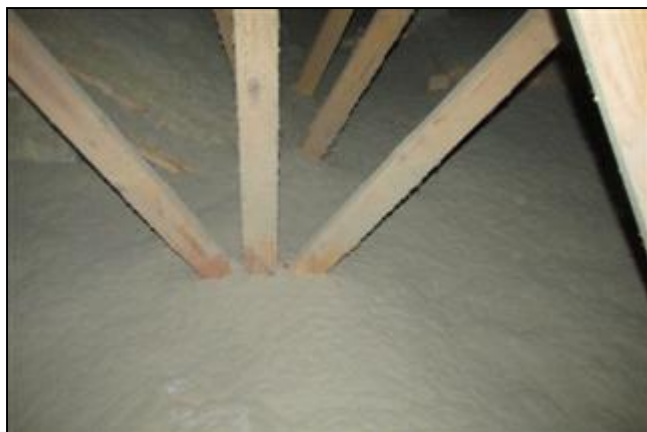
9.0 Picture 1

View of attic insulation (Picture 1).

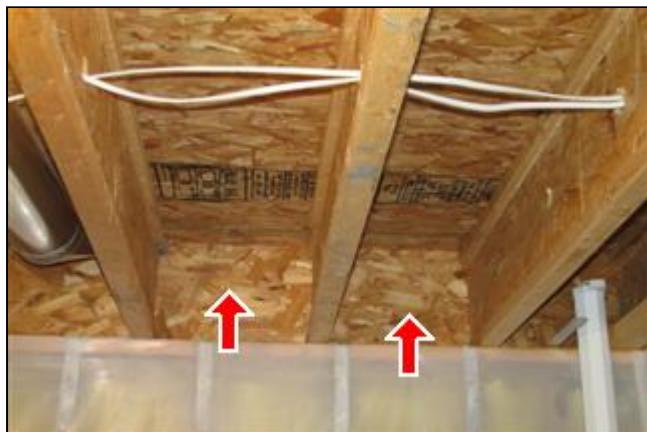
9.1 Picture 1

There is no insulation in the basement between the floor joists along the exterior walls (Picture 1). This should be corrected to conserve energy.

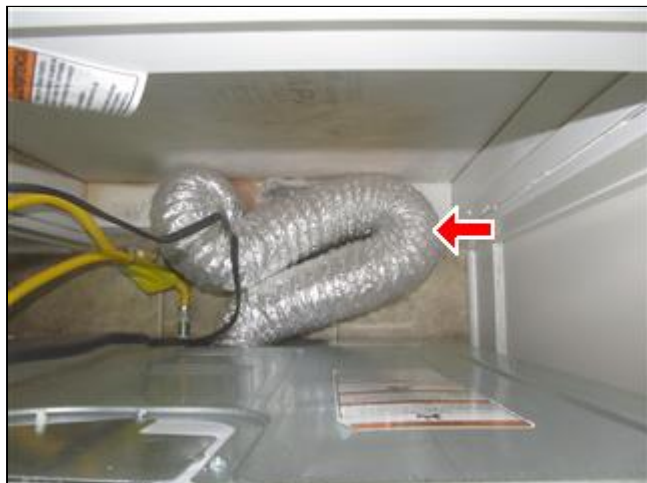
9.4 Picture 1

The dryer vent pipe material in this house is not an approved or recommended type (Picture 1). Flexible aluminum foil vent pipes are not safe and this one needs to be replaced with a smooth, rigid metal vent pipe. *Note: Some manufacturing specifications (shown on the retail carton) list the material as suitable for dryer vent applications. However, the ICC (International Code Council) only approves smooth, rigid metal vent pipes, and the UL (Underwriters Laboratories) only approves smooth rigid metal OR flexible aluminum vent pipe as acceptable.*

The dryer vent pipe material in this house is not an approved or recommended type (Picture 1). Flexible aluminum foil vent pipes are not safe and this one needs to be replaced with a smooth, rigid metal vent pipe. *Note: Some manufacturing specifications (shown on the retail carton) list the material as suitable for dryer vent applications.*

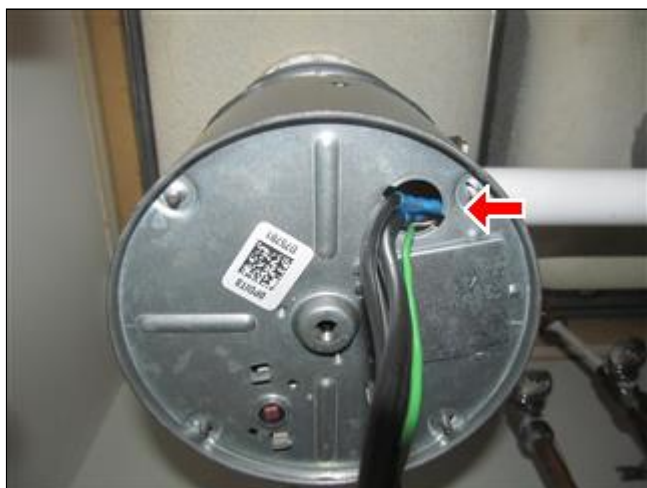
10.4 Picture 1

The garbage disposer under the kitchen sink is missing a romex connector (anti-strain device) right where the wire enters the bottom of the unit (Picture 1). This is an important concern, since the vibration of the disposal can cause the wire sheathing to rub against the sharp metal edges. A licensed electrician needs to make the appropriate repairs.

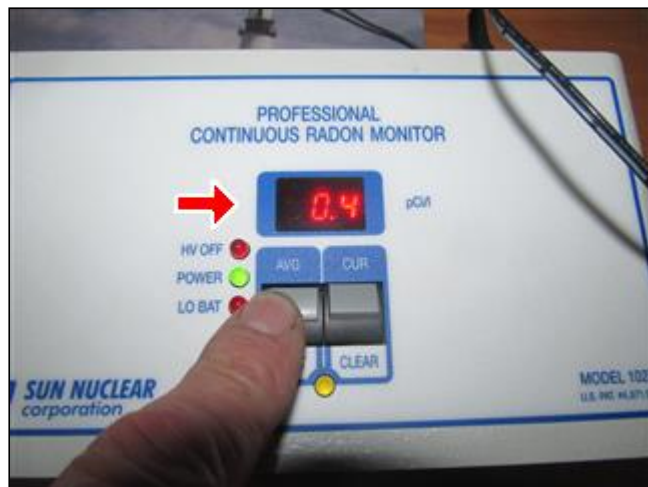
11.1 Picture 1

RADON TEST RESULTS (measured in pCi/L): 0.4 (Picture 1).

Note: This house has a radon mitigation system in place. The system is apparently working, as a reading of only 0.4 is quite low for an indoor environment in Michigan. The outdoor environment in Michigan usually contains at least 0.4 picocuries of radon during normal conditions, and radon is almost always higher in houses due to the stack effect of heat rising, and the tendency for homes to be depressurized compared to the outside environment.
